Manhole Inspection Summary

Manhole # S31Q1_015MH

Location Address: **883 Roundview Rd**

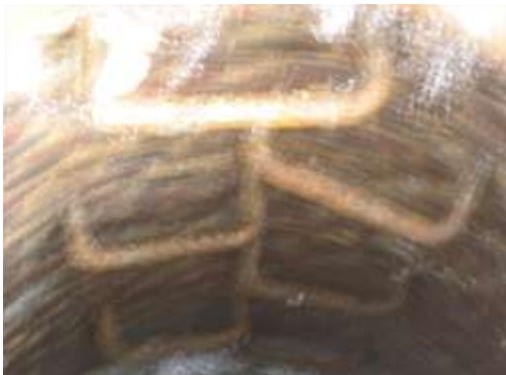
steps

Steps Count: **6** Missing: **0** ☐ Corroded

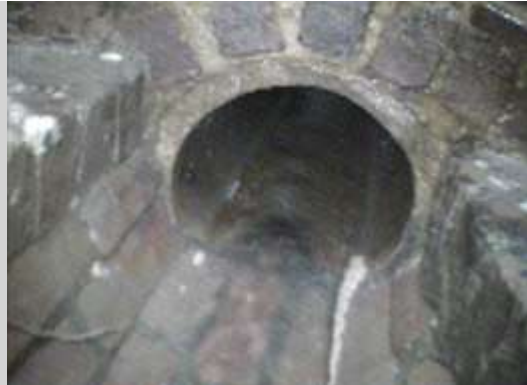
12 O'Clock Outflow

10 in. Circular Gravity Sewer
Pipe Out @ 12 O'Clock

Pipe Height: **12** (in.) Rod and Bar (Angled)
Pipe Material: **Clay** ☐ Pipe Lined
Invert Depth: **10.66** (ft.) Flow Characteristics: **Fast**
Deposits: ☒ None ☐ Mud ☐ Sludge ☐ Debris ☐ Grease
Silt Depth: (in.) Deposits Extent:
Infiltration: **None** Pipe Seal Cond: **Sound**

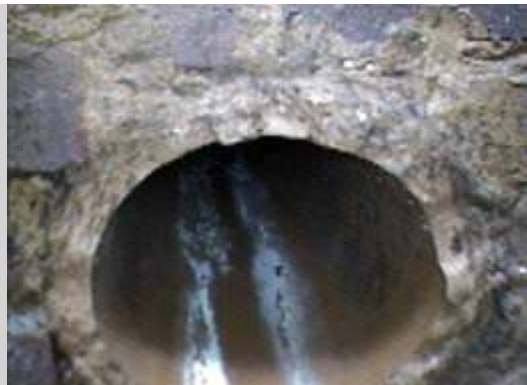
3 O'Clock Inflow

6 in. Circular Service Sewer
Pipe In @ 3 O'Clock

Pipe Height: **6** (in.) Rod and Bar (Angled)
Pipe Material: **Clay** ☐ Pipe Lined
Invert Depth: **3.98** (ft.) Flow Characteristics: **Fast**
Deposits: ☒ None ☐ Mud ☐ Sludge ☐ Debris ☐ Grease
Silt Depth: (in.) Deposits Extent:
Infiltration: **None** Pipe Seal Cond: **Sound**

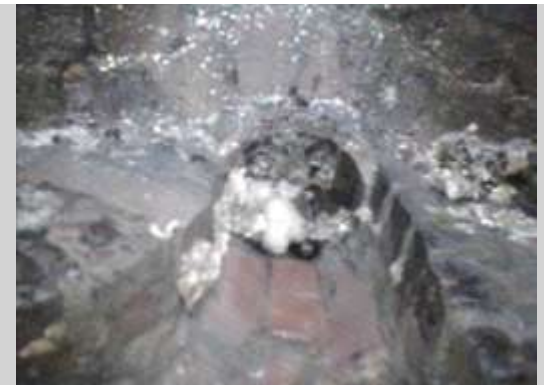
Drop In @ 3 O'Clock

Drop: **Inside** Rod and Bar
Angled: **Yes** Reading: **9.16** (ft.)
Inv Depth: **10.16** (ft.)
Drop Condition: **Open**

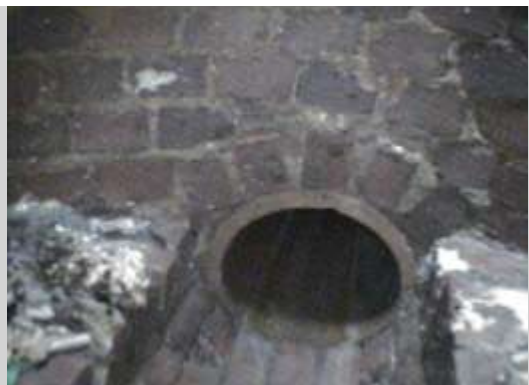
6 O'Clock Inflow

10 in. Circular Gravity Sewer
Pipe In @ 6 O'Clock

Pipe Height: **10.8** (in.) Rod and Bar (Angled)

Invert Depth: **10.54** (ft.) Flow Characteristics: **Fast**

Infiltration: **None** Pipe Seal Cond: **Sound**
